Energy Efficiency in historic buildings

Master of Science (MSc) in Information and Communication Systems

December 2015

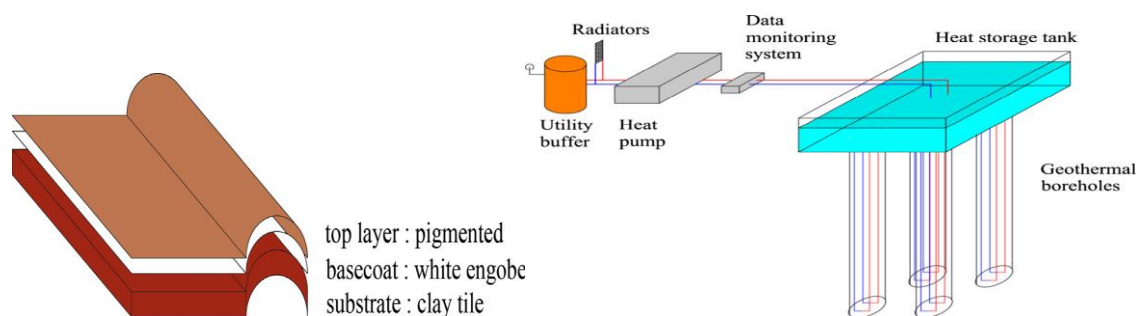
An interesting approach took place in the center of Perugia, in a historic university building, the Palazzo Gallenga Stuart. The purpose of this study was to implement innovative and integrated techniques, in respect of the historic architecture, in the view of sustainability and energy savings. The opaque envelope is composed of bearing stone blocks masonry, brickwork finishing and internal cement plasterboard. The building has a hot water radiator distribution for heating, and condensing external units with fan-coils for cooling. To begin with, the refurbishment include implementation of low impact cool clay in the roof (passive technology) and a geothermal heat pump system with a storage tank (active technology). (Picture 1)

Picture 1: *Passive and active used technology for the restoration of Palazzo Gallenga Stuart.*

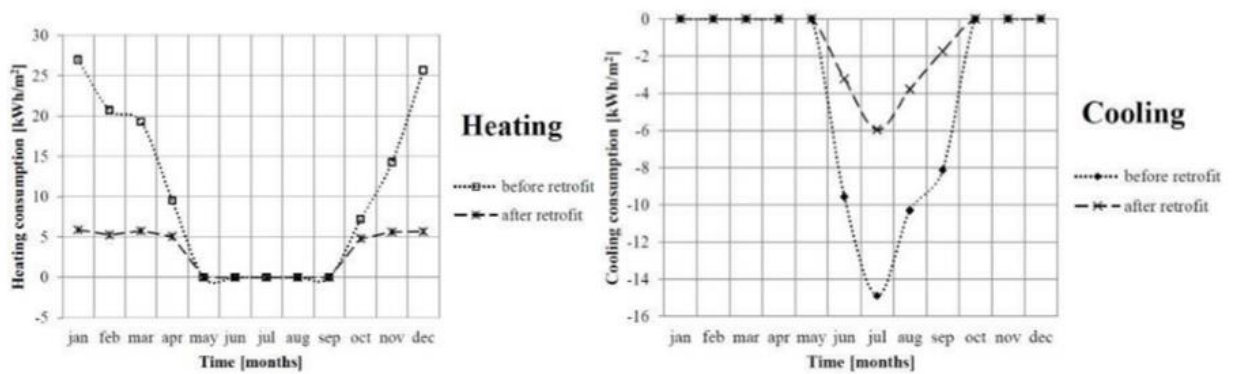
Picture 2: Annual primary energy need for heating and cooling of “Palazzo Gallenga” (a) before the energy restoration and (b) after the energy restoration.

According to the graphs above (Picture 2), the energy retrofit managed to accomplish a reduction almost in half the initial consumption without the interventions in the energy performance. Lastly, this case study shows how can be succeeded reduction in energy consumption of a historic building without any modification of the building’s artistic and value of a heritage building. To conclude, the economic analysis taking into account the combined retrofit systems showed a payback period of 5 years and the life spent for implementing this systems is 15 years. It is important to mention, as it influences the study, that in Italy the regulation about heritage buildings is severe and forbids any change to the façade exterior appearance. (Anna Laura Pisello, 2014)

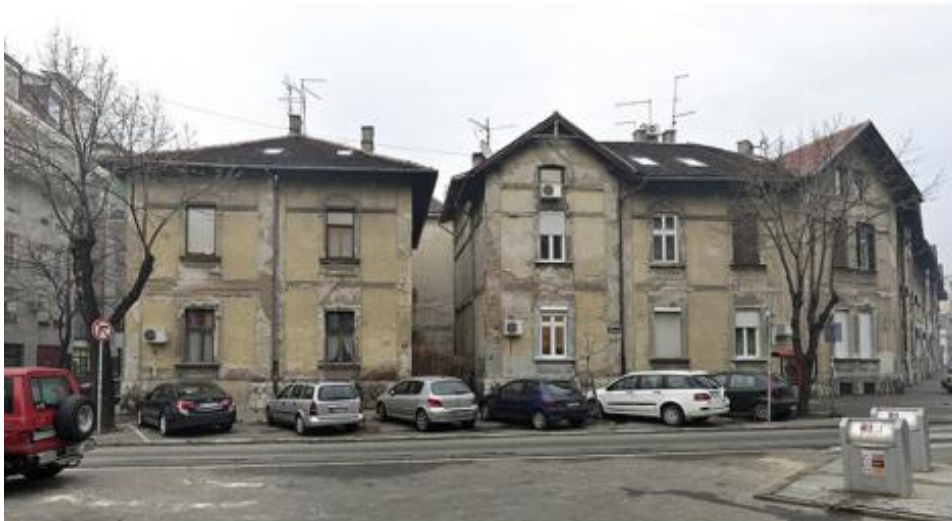
Picture 3: *The houses chosen for restoration in Belgrade.*

The existing elements of the houses were brick masonry as the dominant type of massive wall construction those years, the floor as well as the roof constructions were wooden, and finally the windows were wooden, having double frame, with single glazed sash. The first measurements included only the replacement of the windows and the second interventions added insulation materials in order to reduce heat losses.

In detail, in the walls was put internal 10cm thermal insulation and 5cm layer of insulation in walls attached to unconditioned spaces. Below roof there was an additional 15 cm of thermal insulation, while floor to unheated basement required addition of 15 cm insulating layer. The windows had been replaced by uPVC windows of six chamber profiles, glazed with triple low-E glass unit.

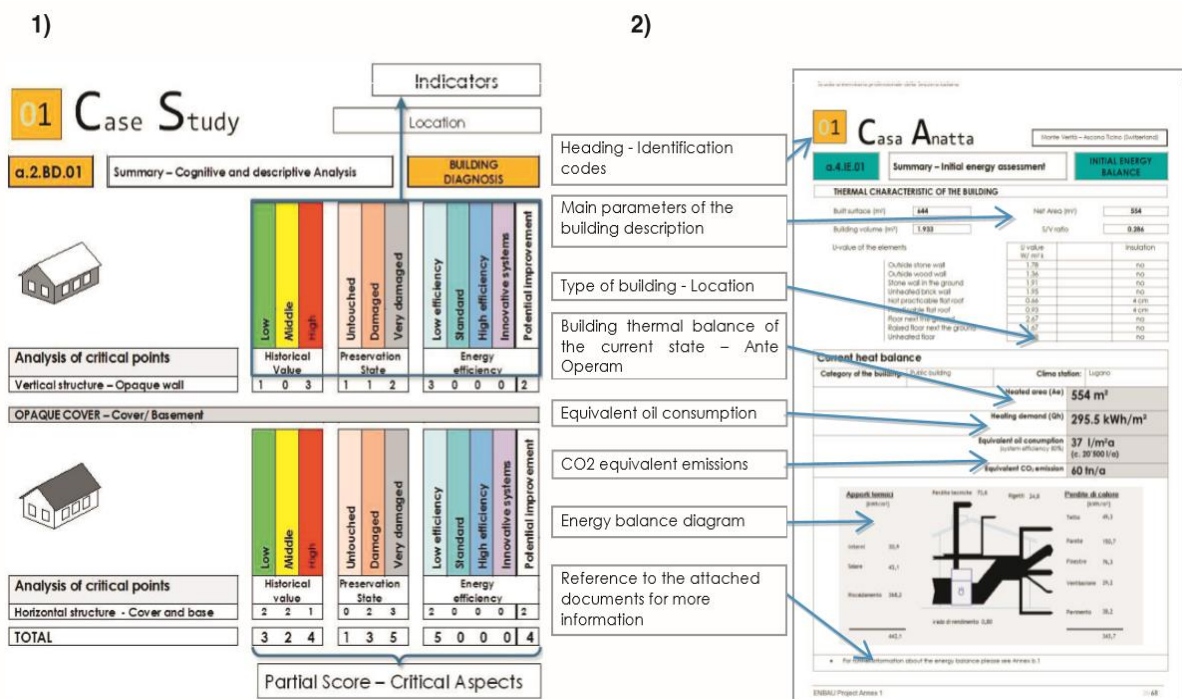
Picture 4: Example of the charts developed during project implementation, first step: Cognitive Analysis, second step: Energy balance analysis chart for setting the current situation of the building.

The used colors are the green, yellow and red. Each energy efficiency restoration measure is categorized according to an established color code as the figure above shows (Picture 4). Symbols are used to identify the involved areas and indicators to assess energetically refurbishment measures in relation to each historical building. Finally the scoring system aims to evaluate these key parameters.

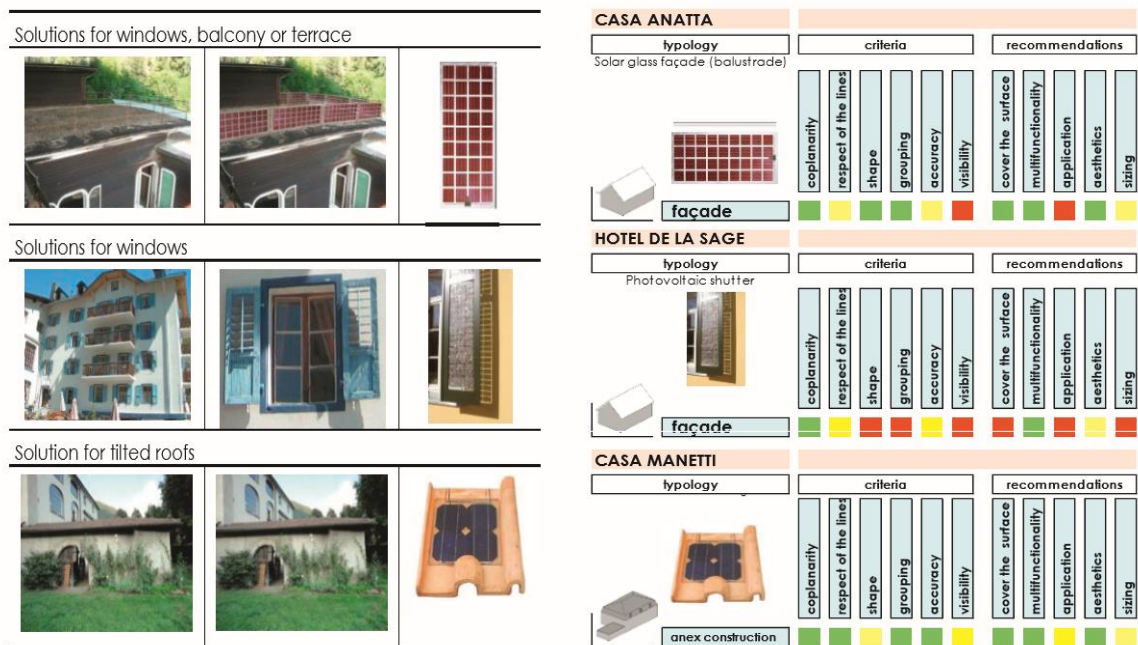
Picture 5: Example for solar energy solutions in the case studies which examined.

year of construction, architectural quality and elements-materials. ENBAU project respects the historical value and assess when renewable sources can be adopted. Aesthetic requirements and balance are estimated in order solar systems be used. Integrating renewable technologies into an urban background, or into existing structures, can upgrade the architectural and technical character of the building in terms of economic and environmental sustainability.

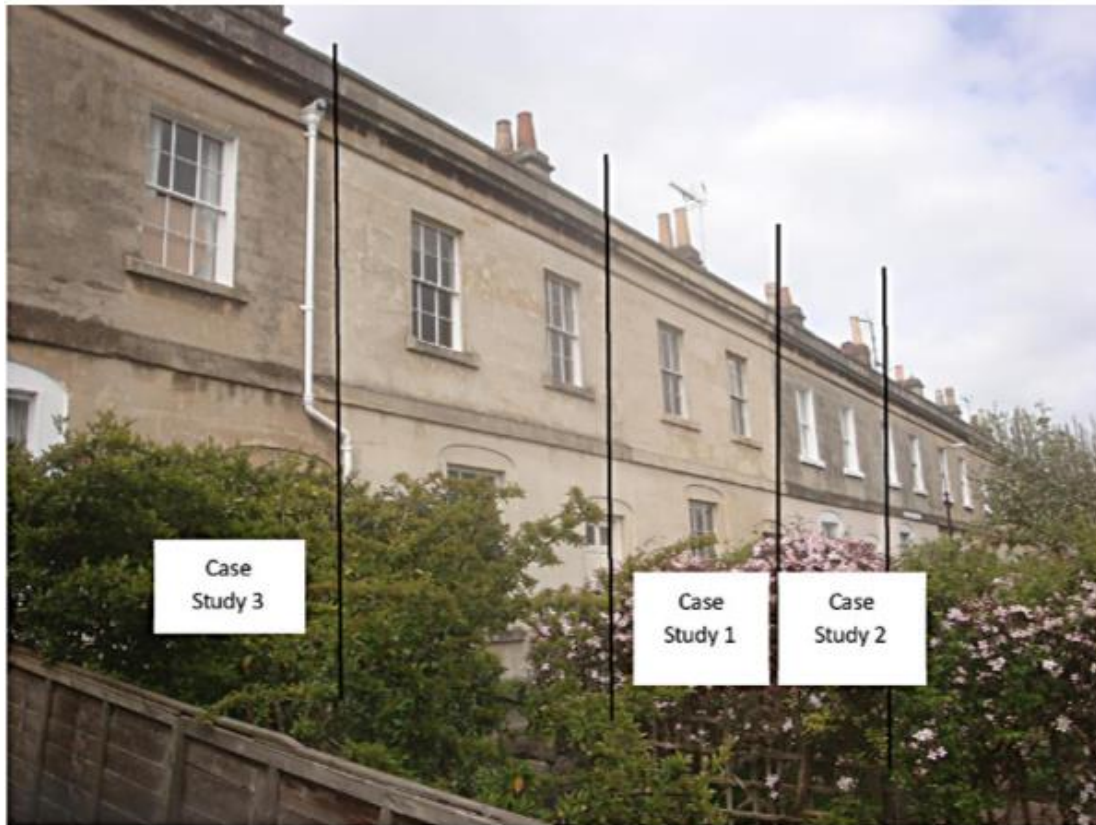
To start with, the 3 buildings are the one next to the other and the year of construction is 1810. (Picture 7)

Picture 7: *The examined buildings*

There were 3 retrofit packages, aiming the reduction of energy use and carbon emissions. The first package includes low cost interventions with the underfloor insulation, increase roof insulation, central heating boiler, central heating pump, replacing the windows and more. The second package focuses on the external walls. Internal wall insulation was putted in order to reduce energy consumption. The external insulation of the walls was avoided due to aesthetic reasons. Finally, the third package introduced photovoltaic and solar hot water systems in consideration of carbon emissions reduction. The results vary. For the first dwelling, the reduction in energy use was about 74% and CO₂ emission about 64%. In the second case study the delivered energy was limited by 54% and carbon emissions by 55%. The highest reduction is notices in the third building with a reduction of 85% and 83% respectively. To conclude, cutting CO₂ emissions by 50% is possible only by putting insulation materials in the buildings. This work emphasizes in the reduction on energy use and emissions with key the realistic heating pattern. (Francis Moran, 2014)

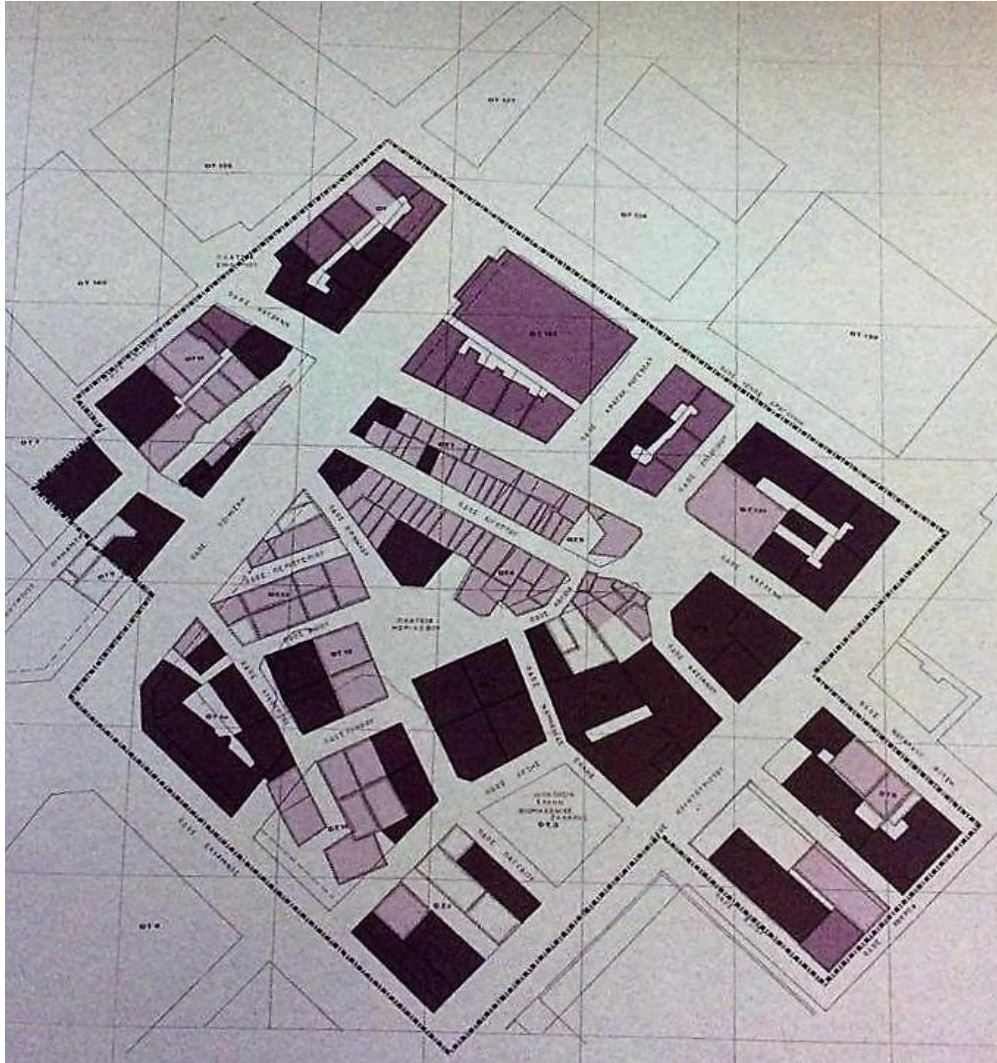
Picture 9: Inventory of the buildings. With light purple are those built before 1917 and dark purple those after 1950

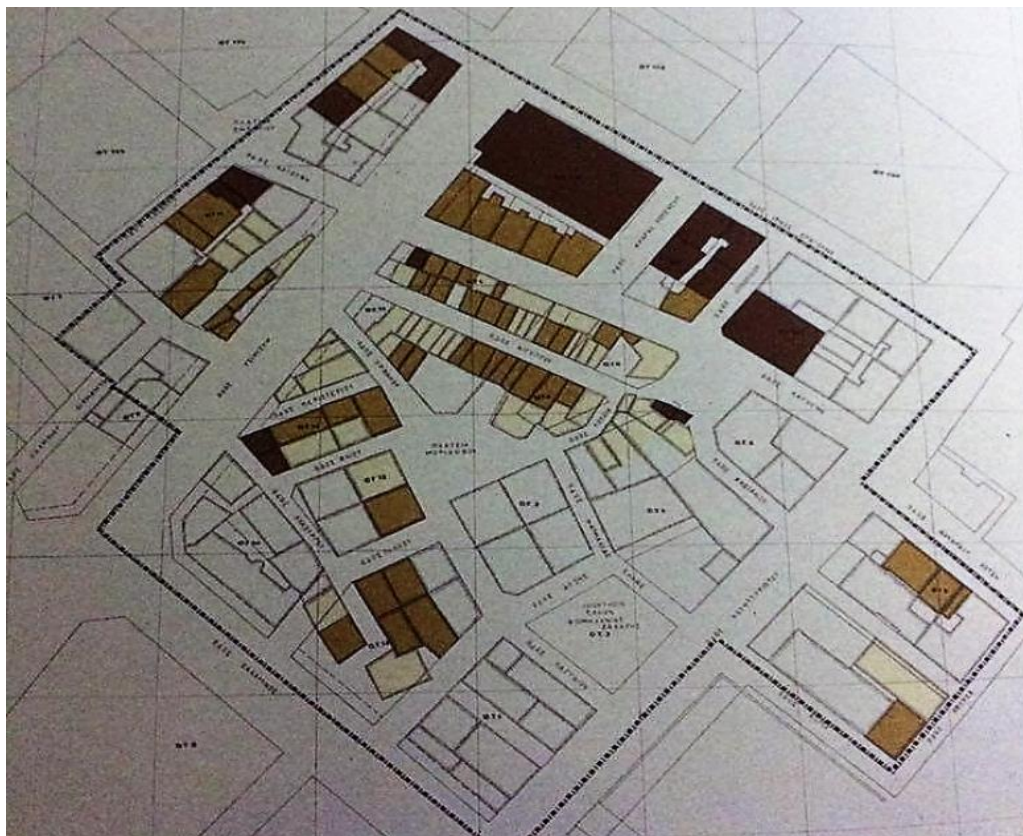
Picture 10: *The situation of the buildings before the intervention. With purple are the buildings found in good condition and with orange those in moderate to good condition. The white buildings found in bad condition.*

After this difficult venture, last century's building complexes, carrying the name "Ladadika", have been rescued. 43 buildings, which survived the 1917 Great Fire, stand on their foundation today and are only one example of these results. (Picture 10)

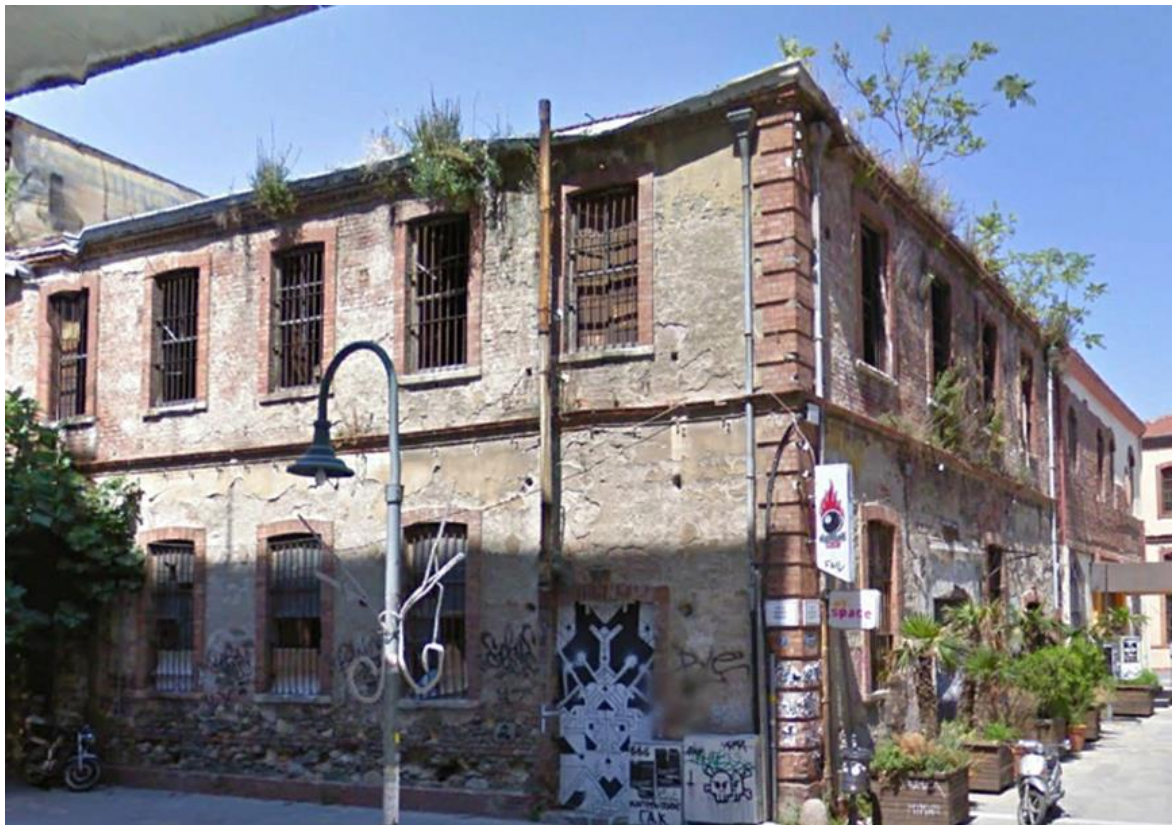
Picture 11: *The examined building in Ladadika, Pindou 9 Street.*

Some of the methods displayed earlier were tested in a case study and helped us fill in the blanks. The object was a building in Ladadika, a warehouse from the 1890s, and the most important fact which we should mention and emphasize is that this building is characterized as listed because survived after the great fire of 1917.(Picture 11) Nowadays the building is not used and this can affect the current situation of the elements.

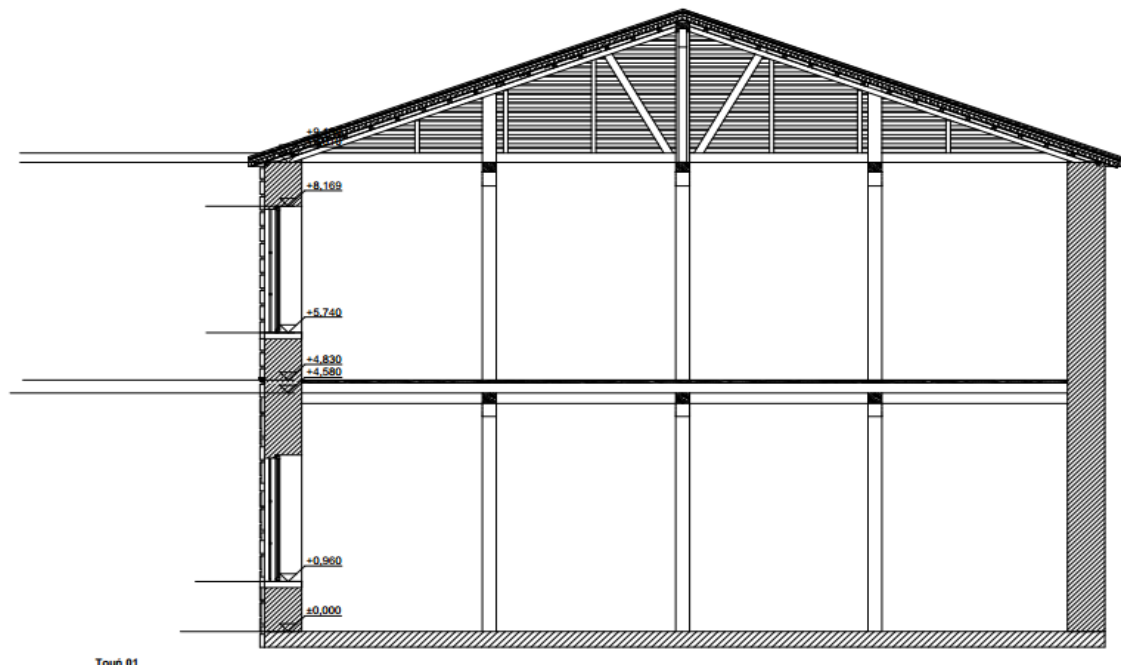
Picture 12: *The incision of the examined building.*

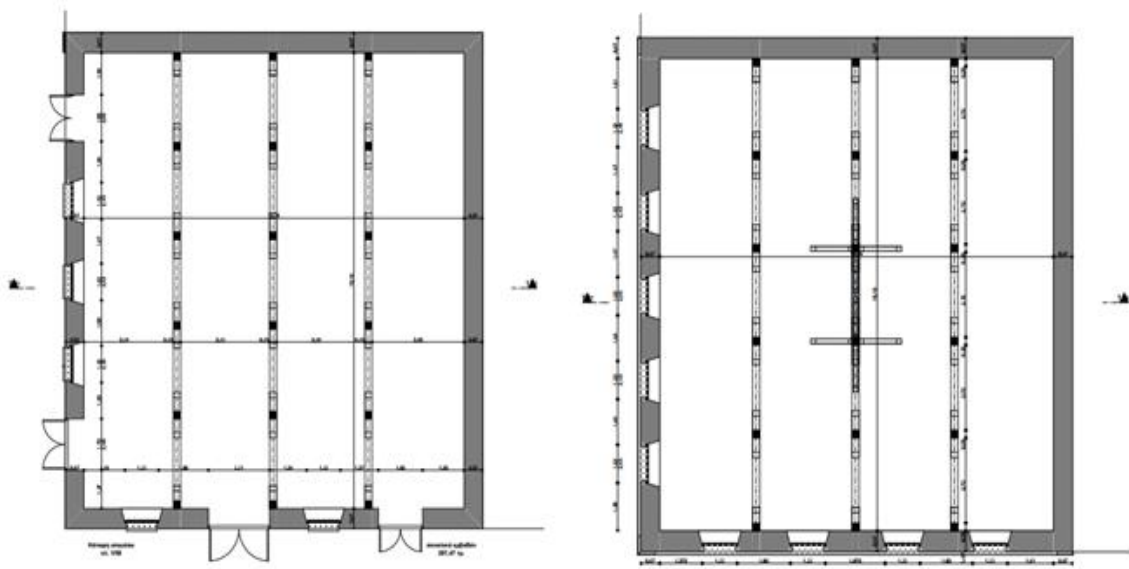
The total area of the place is 415m². There are 2 floors, totally symmetrical and open-plan, practically without interior walls. (Picture 13)

Picture 13: *Plan of the 1st floor (left) and the 2nd floor (right) of the building in Ladadika.*

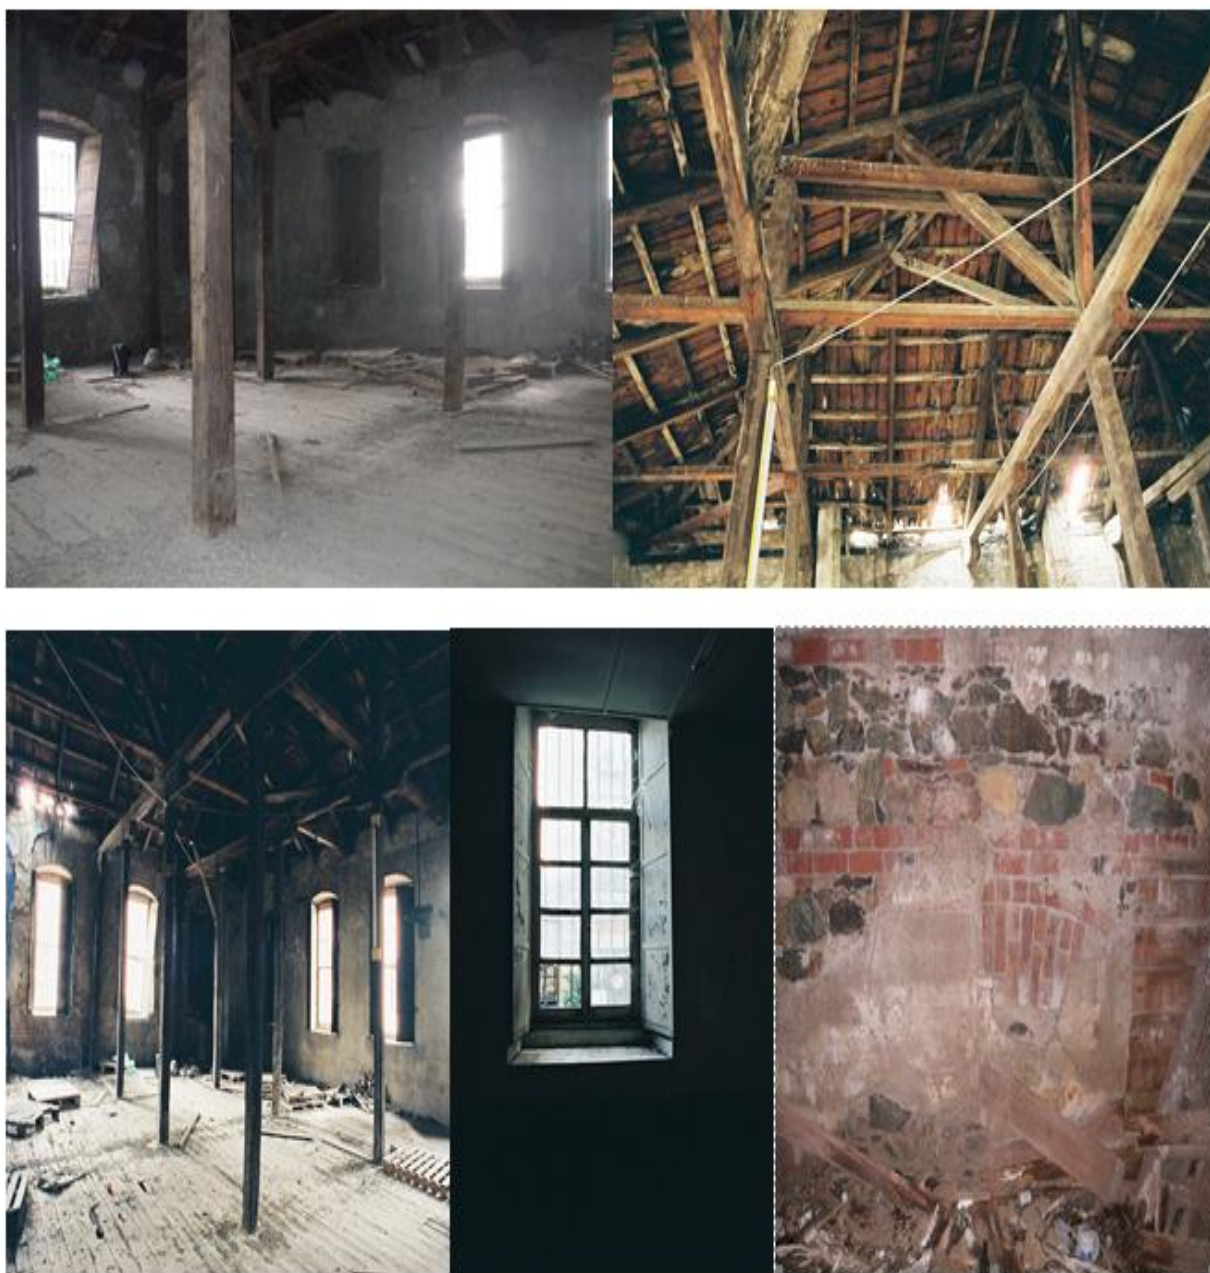
Picture 14: *The internal space of the building and the existing elements.*

The construction is characterized by the number of the openings which reach the number of 18. The windows are also relatively large, one glazed windows with metallic frame and without thermal break. In addition, the existing doors are also metallic. The floor is wooden, adjusted to the ground and the roof is an area of plain tiling upon wooden ceiling. As far as the walls are concerned, in the first floor the main material is rough fragments of stone coated from both sides. The main reason for these elements is to ensure that the building would be solidly attached and stable. The walls of the second floor consist of double bivalve bricklaying. (Picture 14)

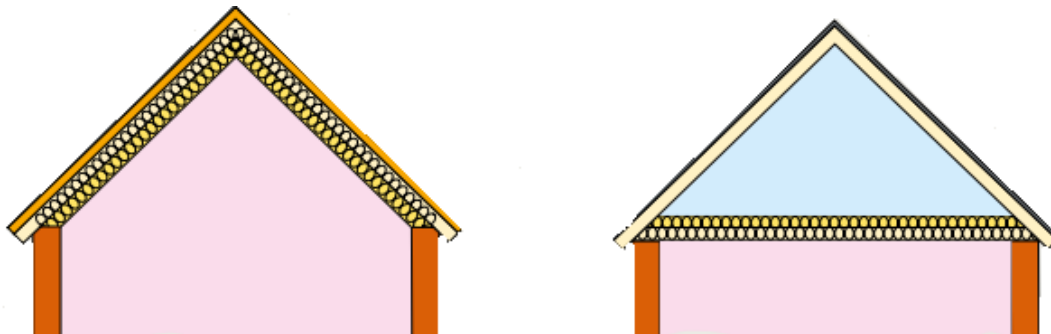
As far as the roof is concern, the quandary was great. The roof is pitched and covered with tiles, meaning that the insulation could be designed in 2 ways. (Picture 16) The first technique includes insulation at the level of the horizontal ceiling of the topmost floor, leaving an unheated roof area, like a loft above the insulation. On the Contrary, the second method has insulation between or over or under the sloping rafters, in order the total volume under the roof be heated and used. (Ogley, 2010)

Picture 16: *The 2 techniques of roof insulation. (Ogley, 2010)*

For the examined building, the most proper method is the first. As a grocery-shop the space should be heated or cooled effectively. For that reason the second method would demand higher volume to heat and this would be aimlessness. In addition, humidity will be reduced owing to the ventilation of the attic. The used insulation stuff for the construction is natural fibre like sheep's wool and also plywood and felts coverings were placed. The thickness is 5cm and the Thermal Resistance (R) 1,22 m²K/W which lead

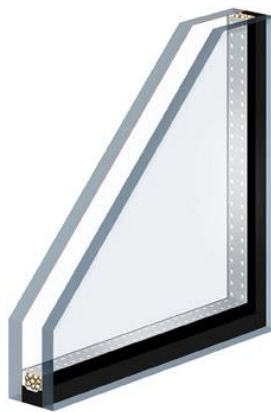
Picture 17: A double glazed window.

Infiltration rate reduces considerably the energy performance of a building. The openings contribute to high energy, heating and air losses and for that reason the windows should change. A historic building should not affects its external appearance and that is why the changes must be restricted only in the windows. The metallic frames without thermal break will remain. The existing place of activity has single glazed windows, and their position take double glazed windows and air gap of 12mm.

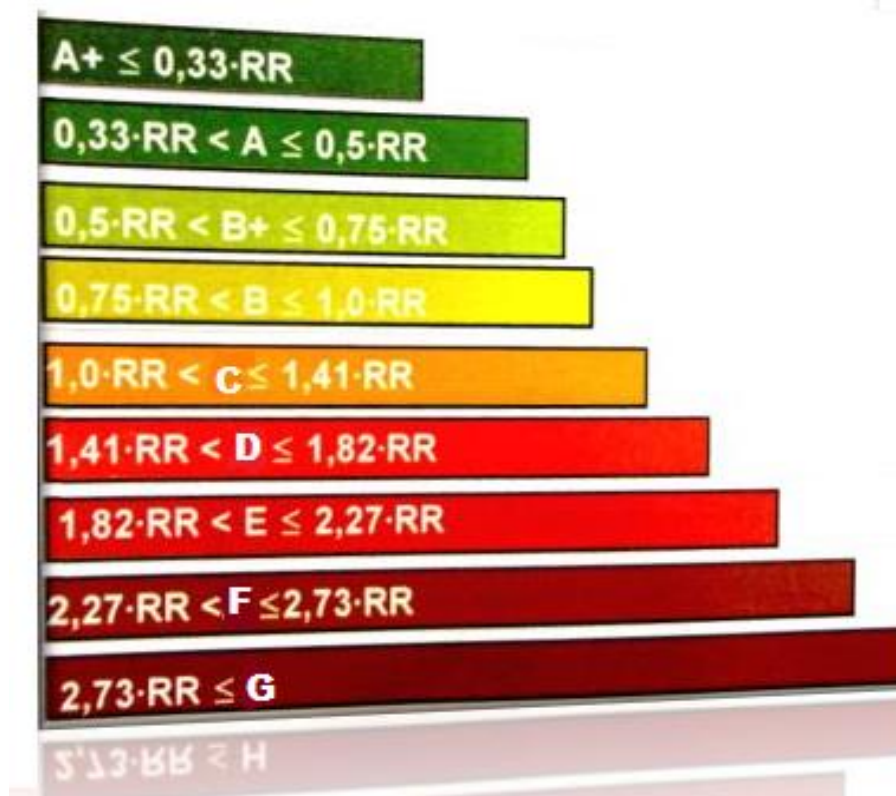
Picture 18: *Proposal of ratings of buildings for different classifications. (Greece).*

This software implements the necessary algorithms for calculating the energy performance of buildings in Greece, based on the methodology of the European standards (ELOT EN ISO 13790, etc.) as well as on the relative national models and the corresponding TEE. Furthermore, the software is used for the energy audit process in order to calculate energy efficiency and energy classification of buildings in order to issue the Energy Performance Certificate - SMO. It is also used in the preparation stage and submission of the study and only for energy efficiency calculations and energy rating of the building in order to have a common methodology and consistency of study results with those of the energy audit after the completion of construction of the building. The Energy classes, in connection with the Primary energy are in the next Figure. (Picture 18)

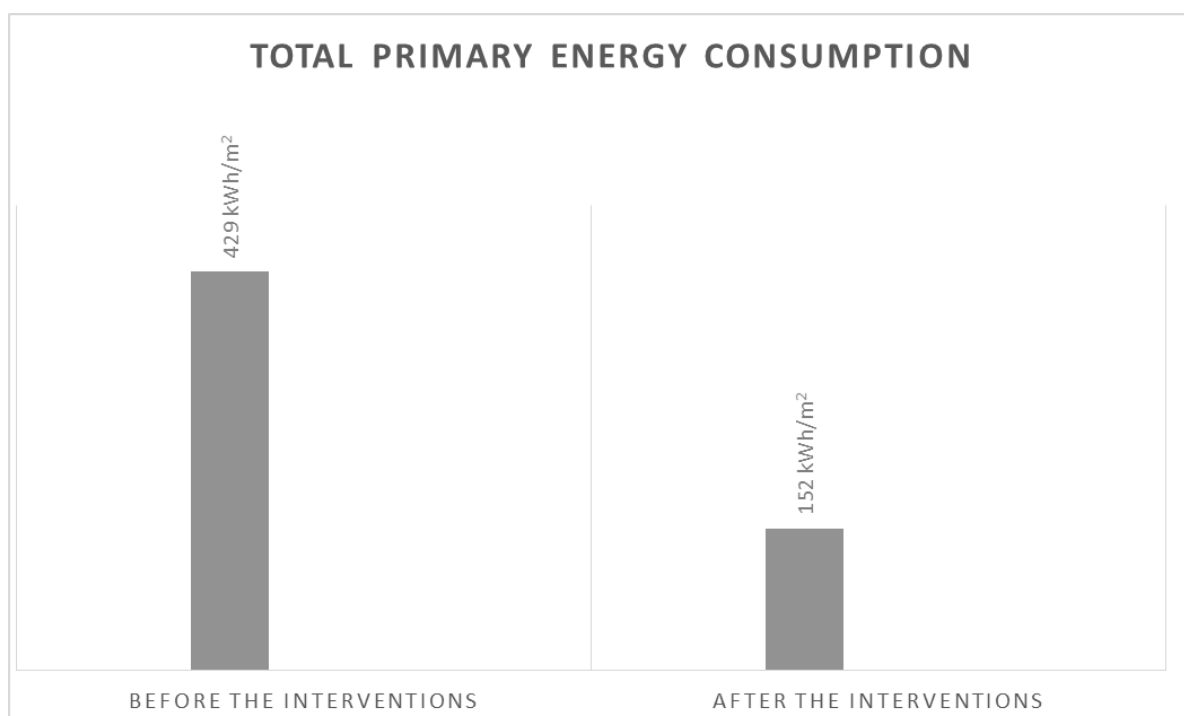
Graph 1: *Primary energy consumption before and after the interventions.*

In the next graphs a comparison between the situation before and after the interventions will be presented in order to have a better eye on the results. The first graph (Graph 1) presents the total change of the primary energy from which also depends the energy class of the building and the energy efficiency generally. The reduction stands at approximately 65%.

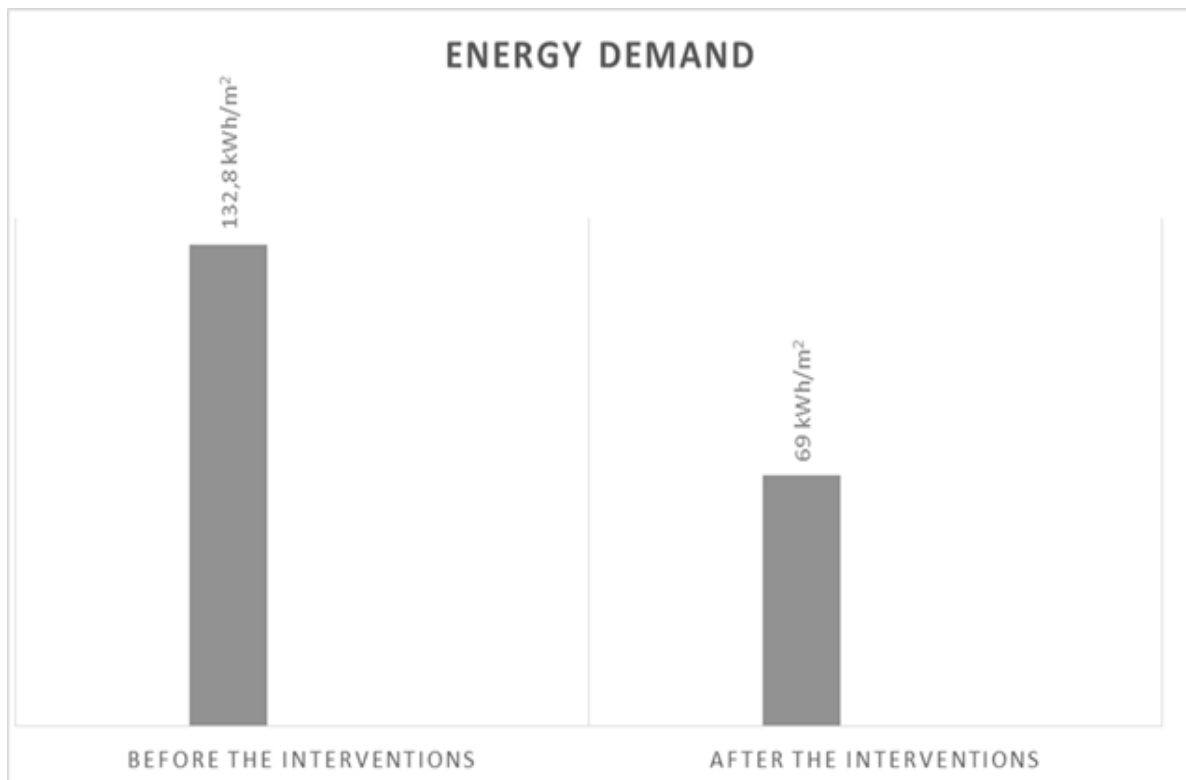
Graph 2: *Comparison of the energy Demand before and after the interventions.*

The graph below shows the energy demand. (Graph 2) It is obvious that the reduction is great. The building now requires almost 50% lower energy than before and this is a great key for the energy performance.

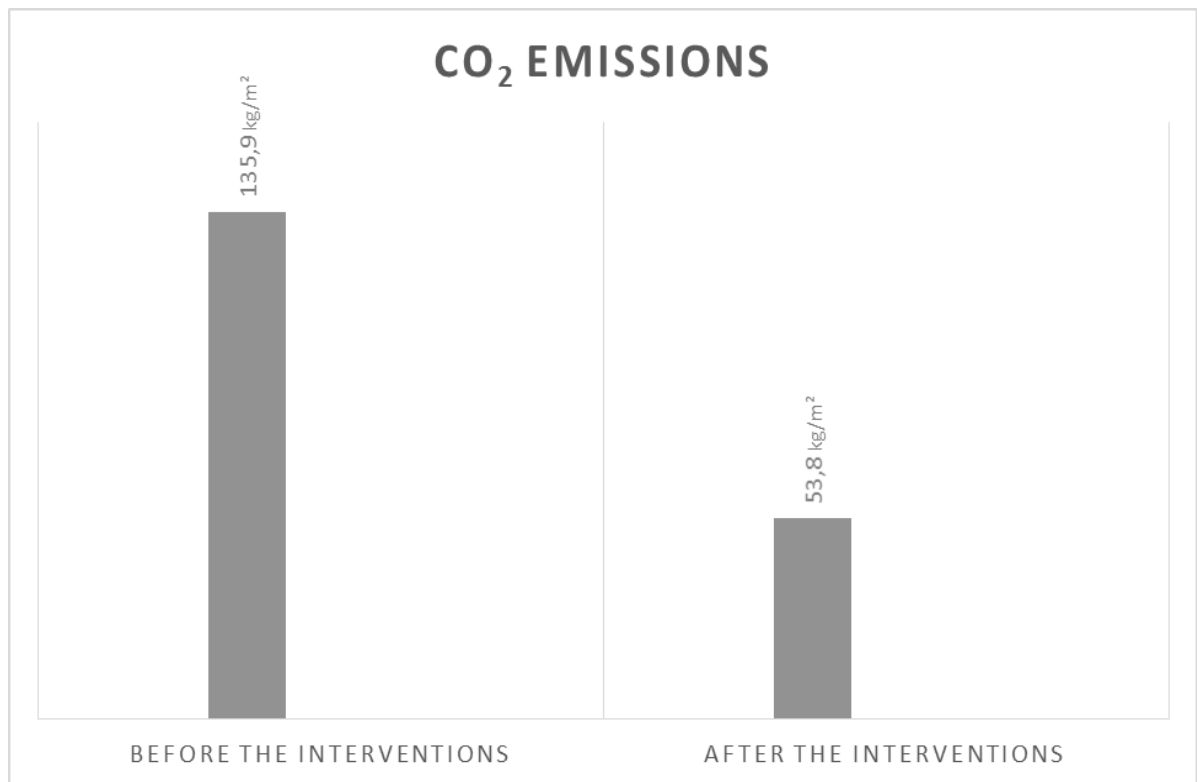
Graph 3: *CO₂ emissions before and after the interventions.*

CO₂ emissions for buildings built before 1919, reach the 86 kg CO₂/m². Despite this information, a work done by Moran, has displayed that the EHS can overestimate the energy use of a historic construction by 44%. (Moran, 2012) But from a logical point of view, it is clear that a historic building could play a great role in attaining emissions aims. In the next graph (Graph 3) someone can notice the huge reduction on CO₂ emissions after the interventions. CO₂ emissions after the renovation project are more than 60% lower than before. To this reduction contributes importantly the fact that the heating and cooling systems now consist of a heat pump and not of oil boiler.

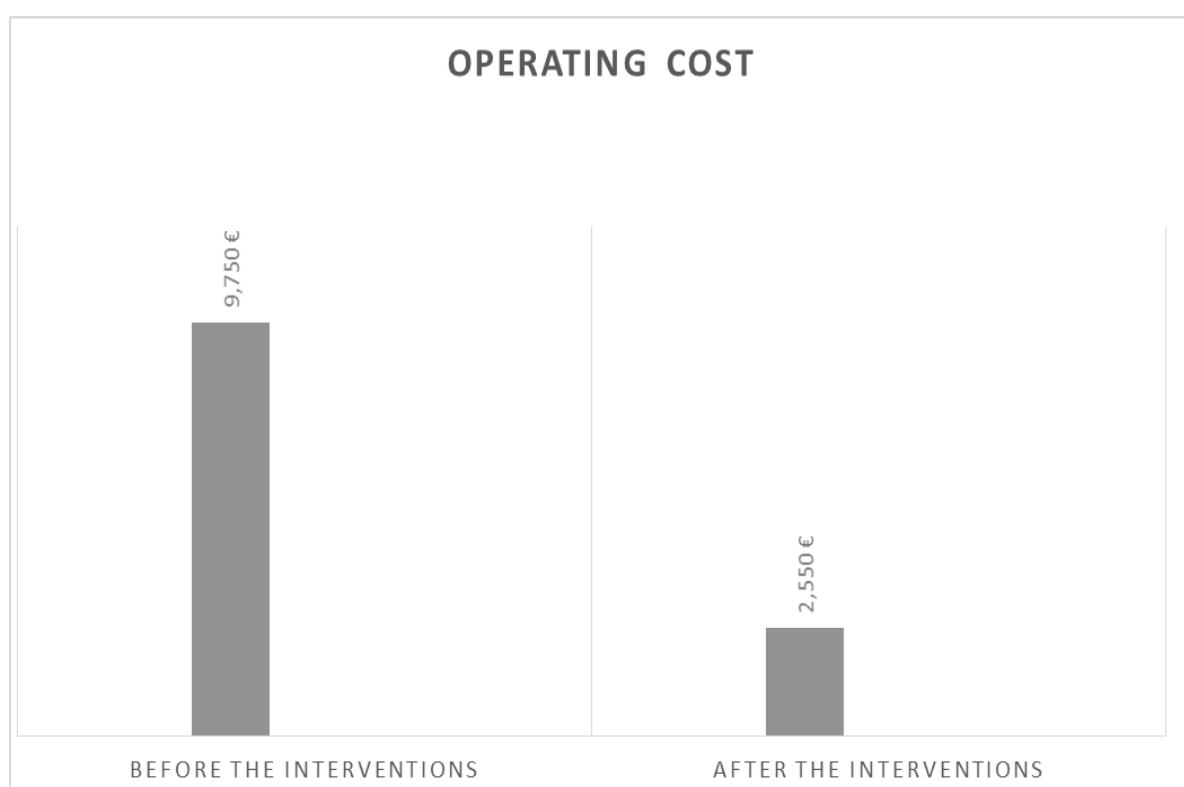
Graph 4: The operating cost before and after the interventions.

Finally we should not forget to discuss the operational cost. (Graph 4) Even though this dissertation has not studied the economic point of view, the operational cost has decreased significantly due to the more profitable solutions. The maintenance and the expenses will be more efficiently economic and give the opportunity for a more tempting use of the building with more opportunities for investment.
